5. PHYSICAL CHARACTERISTICS

| <div>Map of Geologic Information</div> <div>Removal Site Evaluation for Anomaly Area 3</div> | | | |

| Removal Site Evaluation for Anomaly Area 3 | | | |

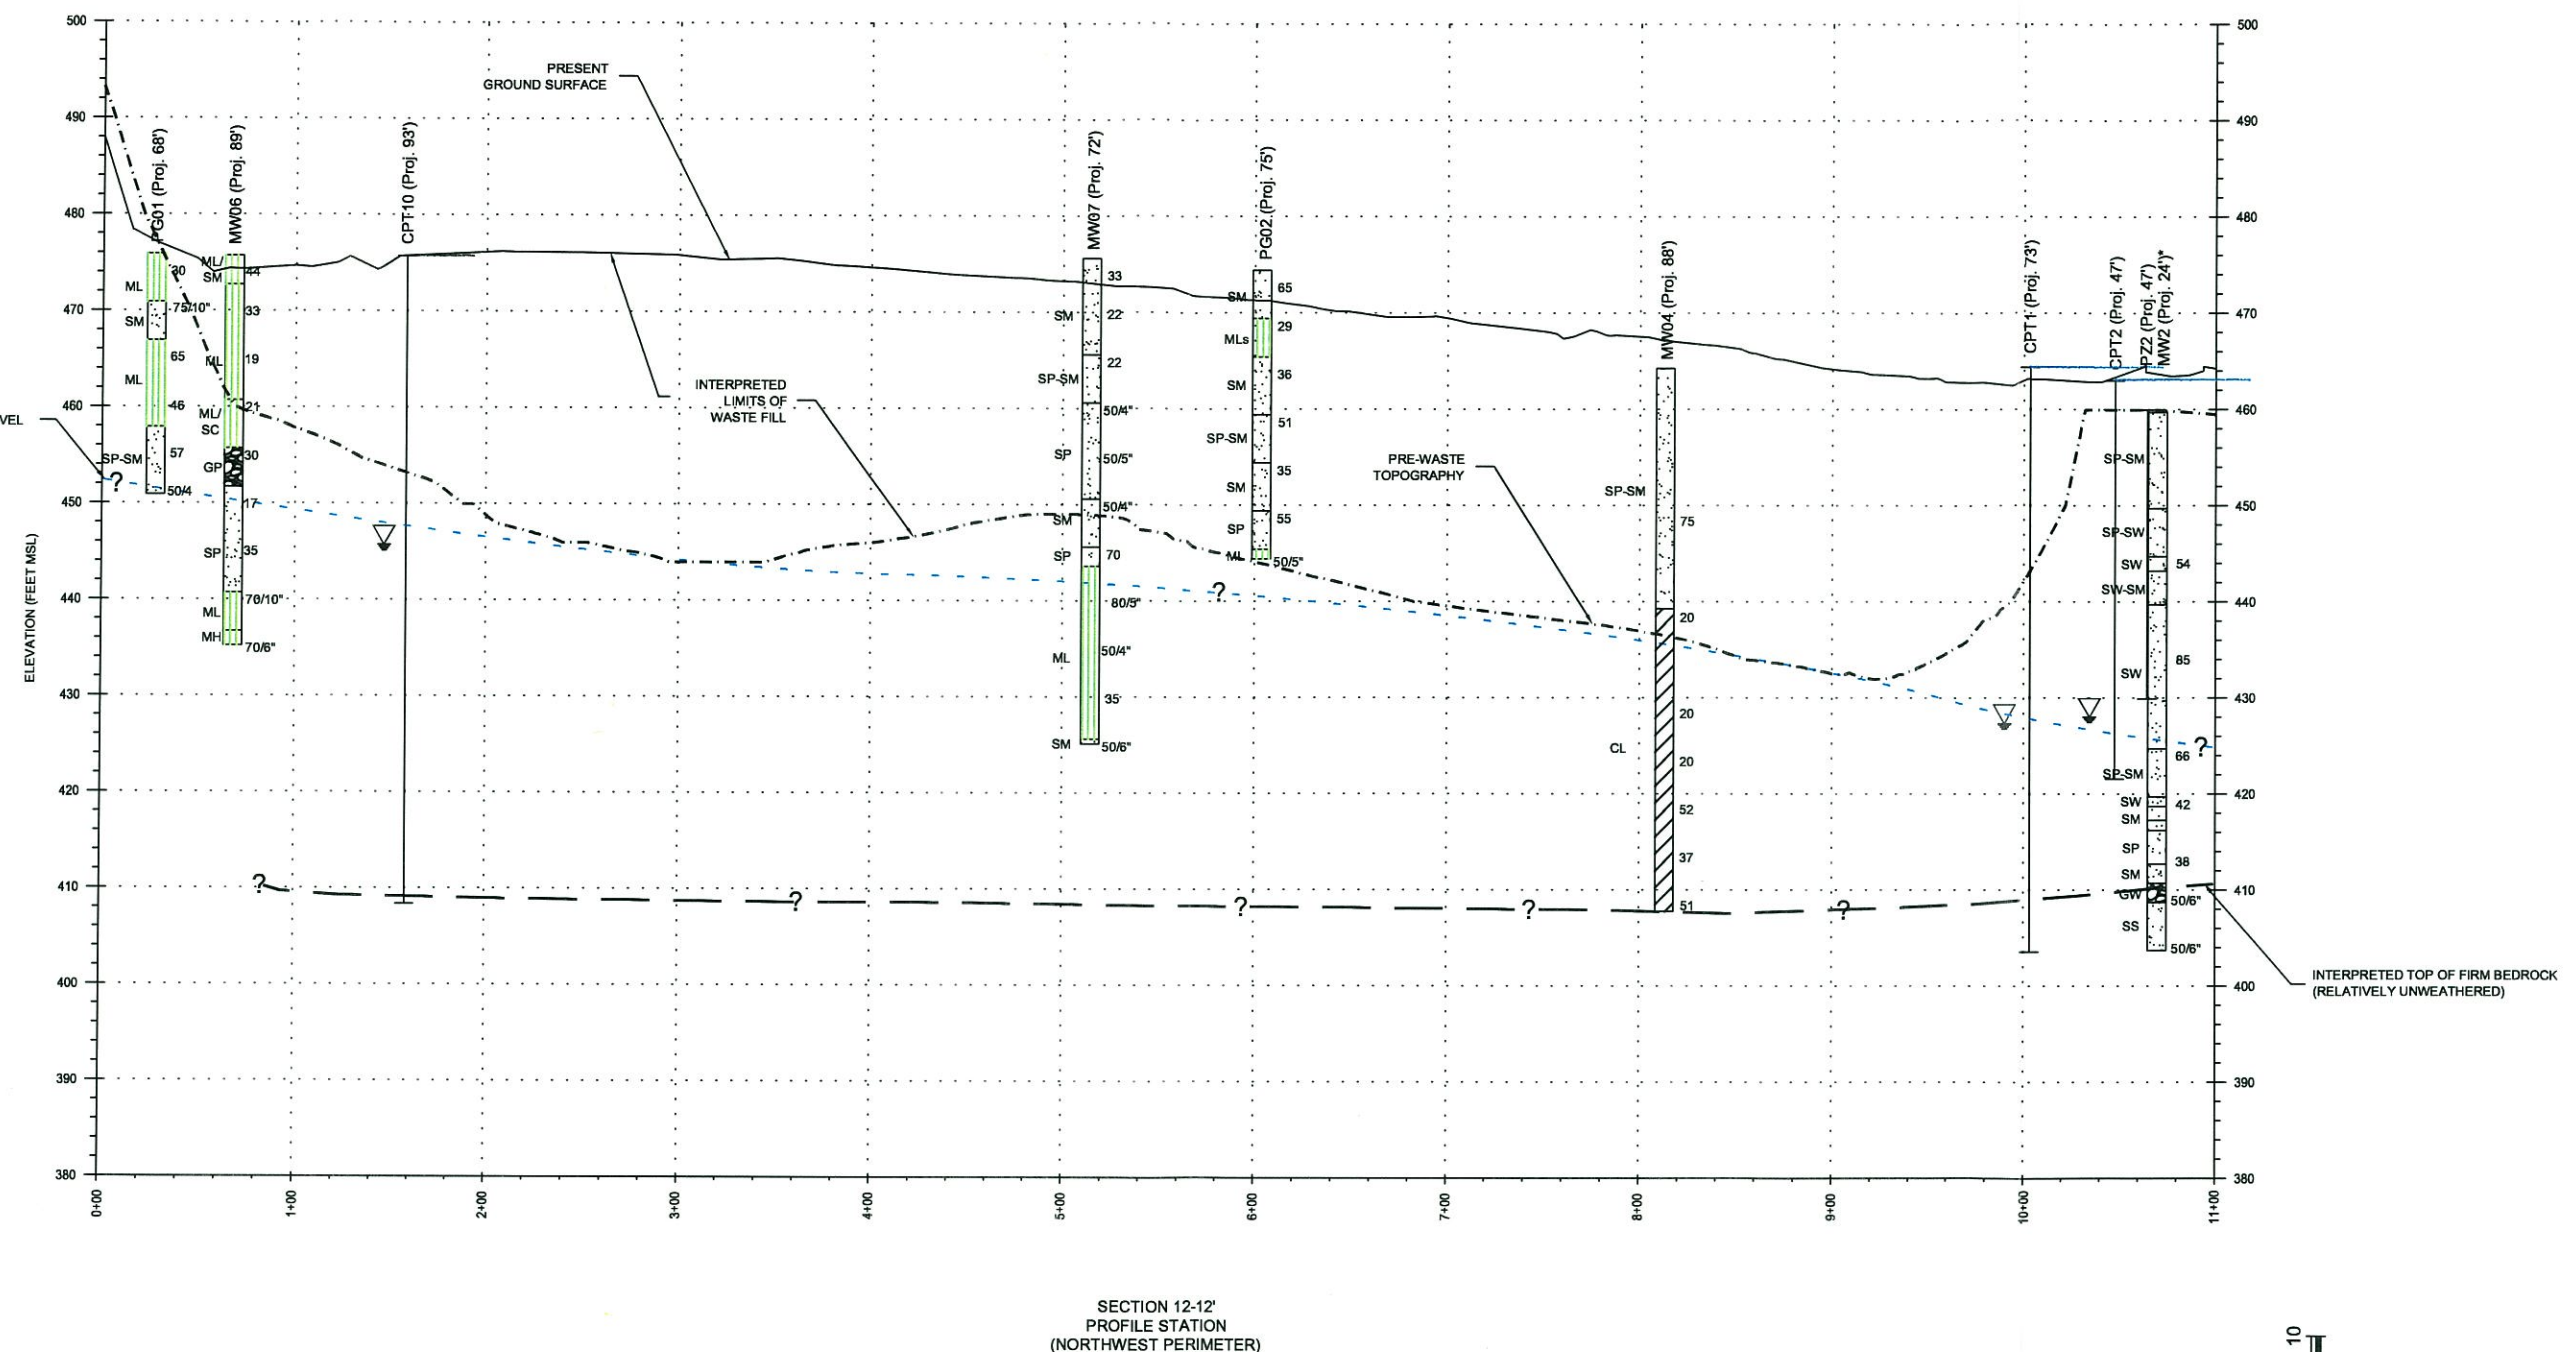
SECTION 12-12'
PROFILE STATION
(NORTHWEST PERIMETER)

| Section AA3-12-12' | | | |
| Interpreted Subsurface Soil Conditions | | | |

A summary of field explorations providing ("deep") subsurface soils conditions is provided in Table 5-4. Figures 5-8, 5-9, and 5-10 show approximate limits of man-made fill (debris), underlying Agua Chion wash alluvium, groundwater level, and the interpreted depth to bedrock.

Groundwater is estimated to be approximately 40 to 60 feet bgs, and ranges in elevation from approximately 425 to 450 feet msl from northeast to southwest, as shown in Figures 5-8, 5-9, and 5-10.

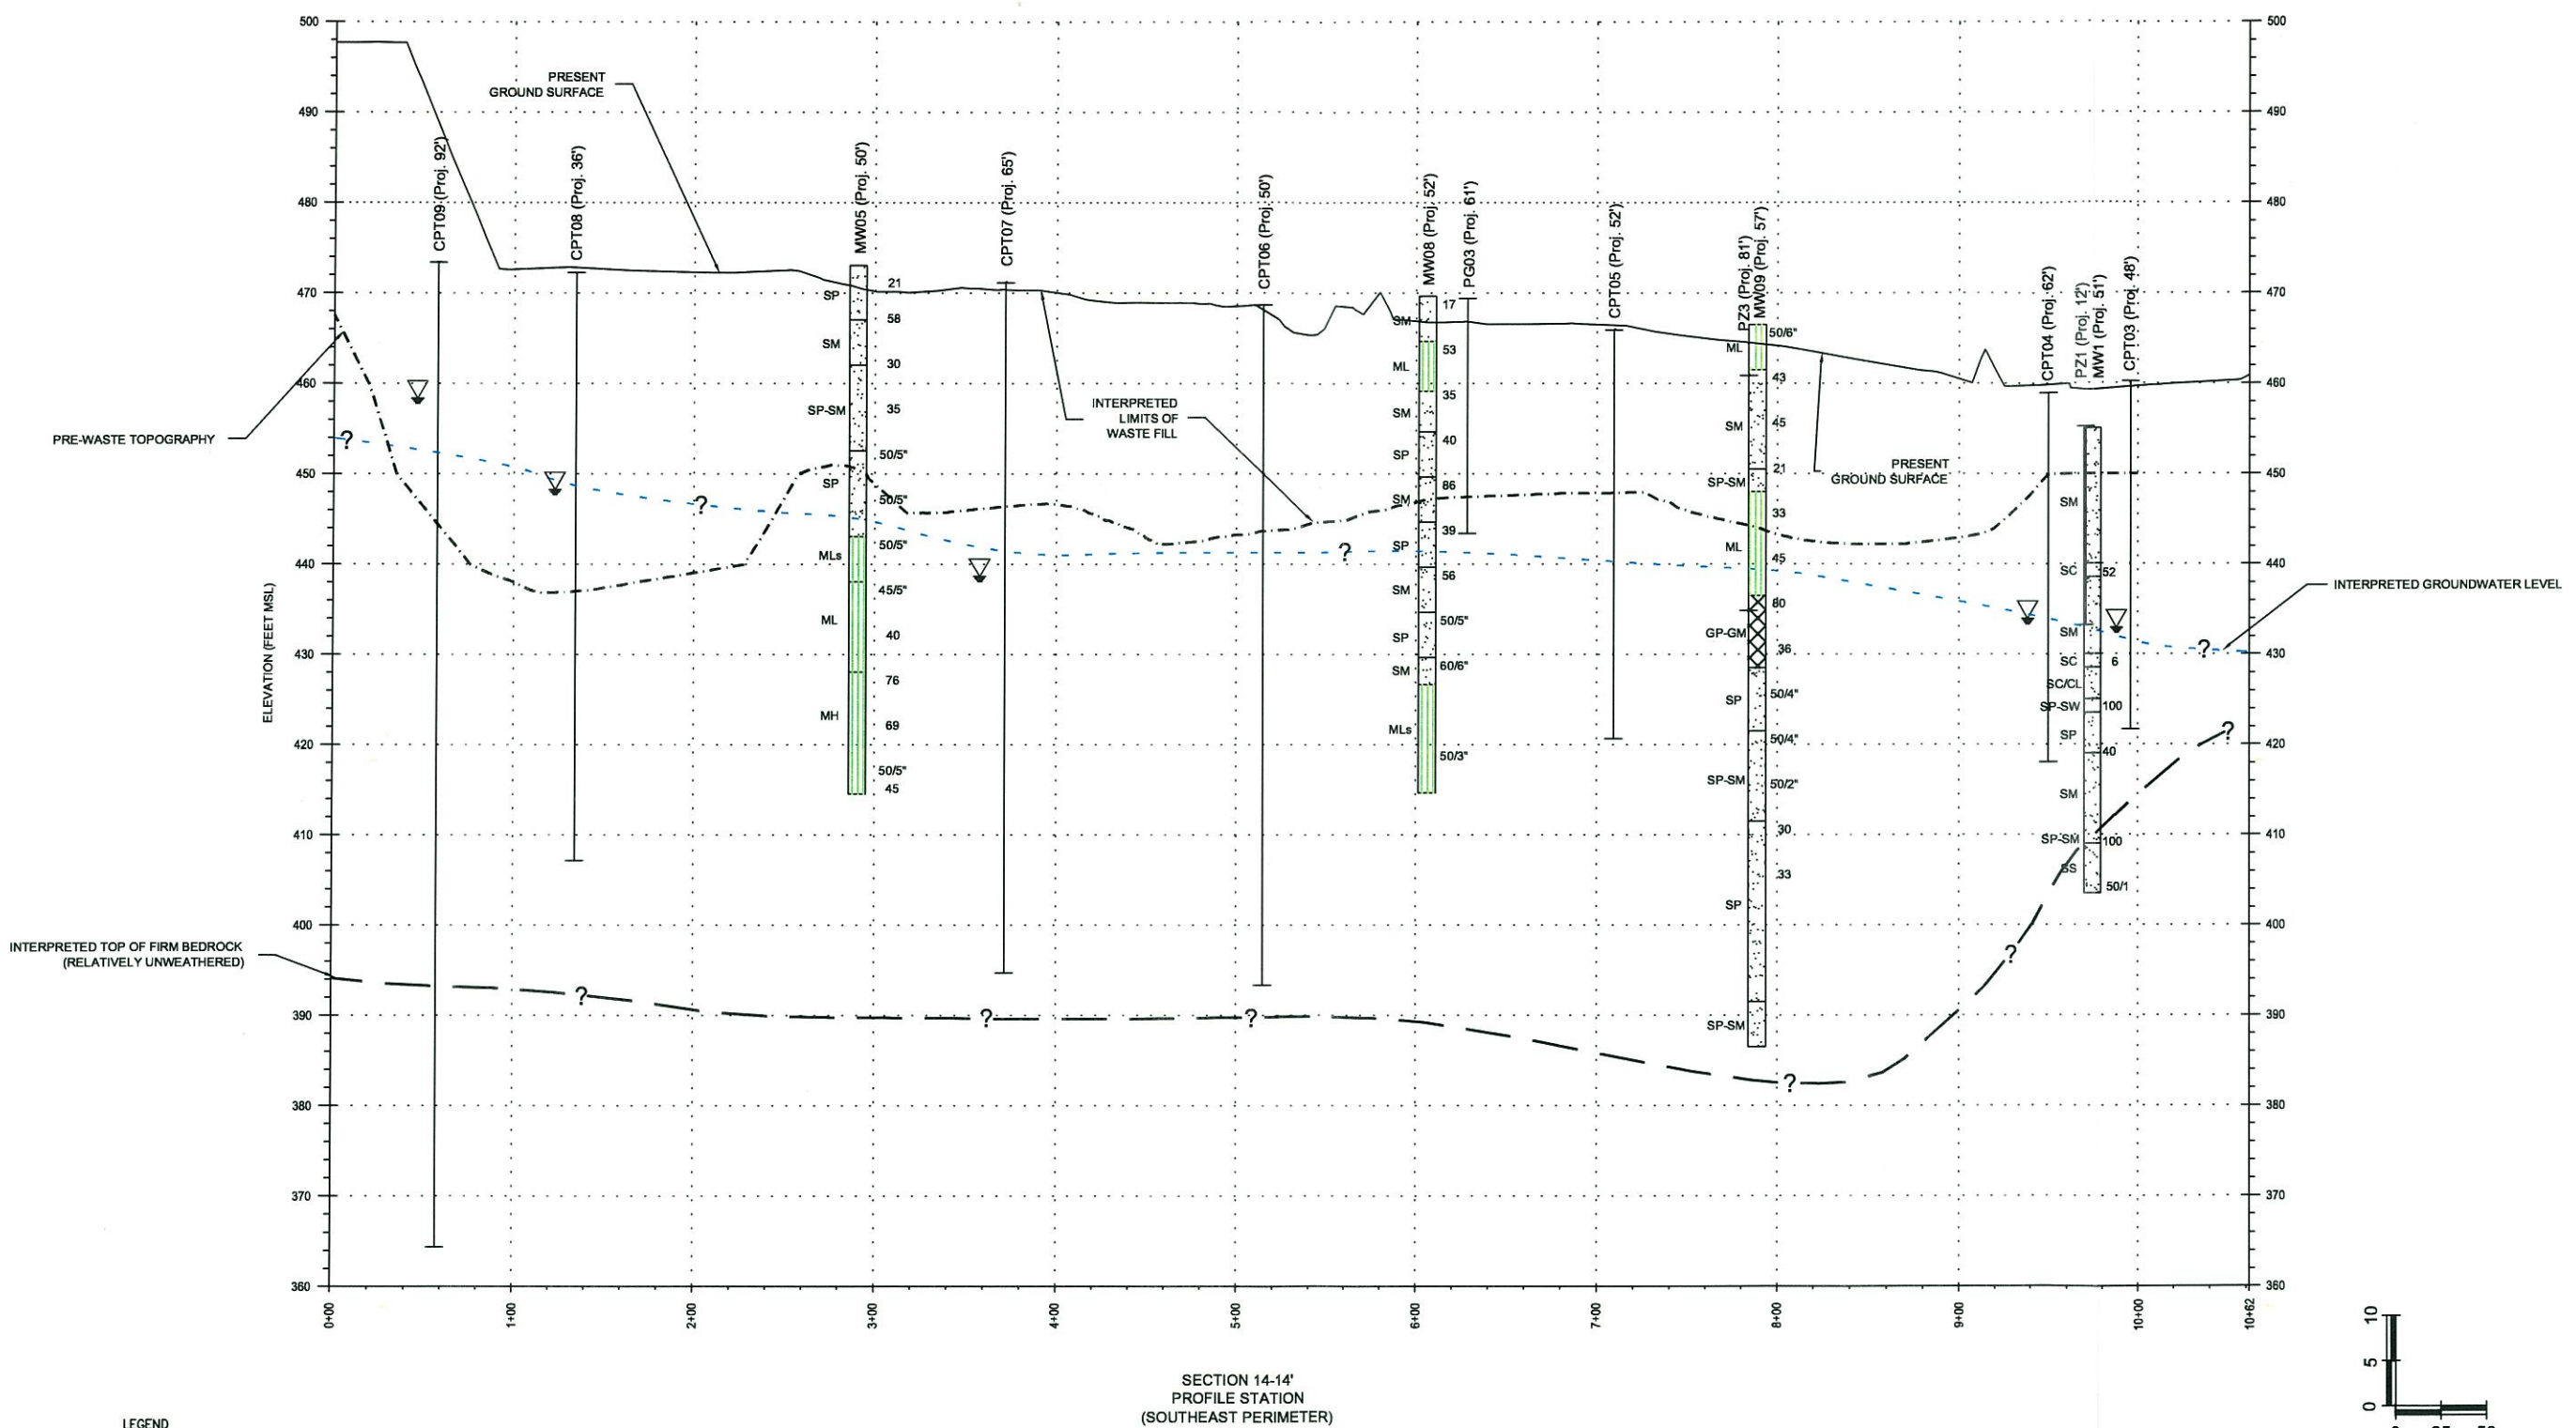
| Date: 11-03 | Former MCAS El Toro | | Figure 5-10 |

| Section AA3-14-14' Interpreted Subsurface Soil Conditions Removal Site Evaluation for Anomaly Area 3 | | | |
